Manhole Inspection Summary

Manhole # S29K__070MH

Insp Date: **2/2/09 1:22 PM**

Location Address: **801 Ramsay St.**

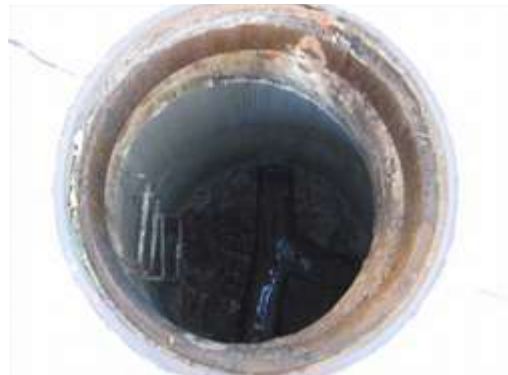
Defect 4

Offset: **1** (in.)

frame offset

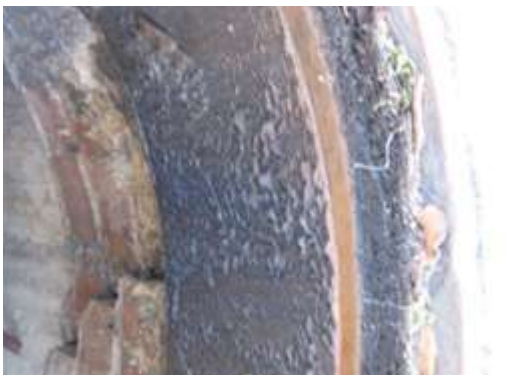
Defect 3

Condition: ☐ Sound ☐ Cracked ☒ **Leaks**

infiltration from lid

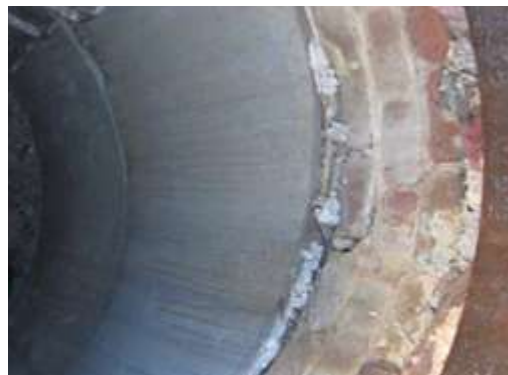
Defect 2

Condition: ☐ Sound ☒ **Cracked** ☐ Root Intrusion ☒ **Loose Brick** ☐ Deteriorated

Count: **5** Missing: **0** ☒ **Corroded**

corroded steps, loose bricks chimney

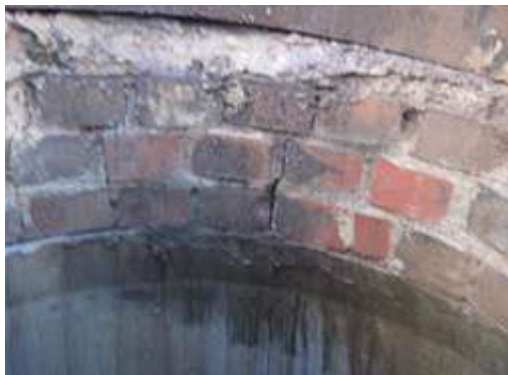
Defect 1

Infiltration: ☐ None ☐ Joint ☐ Cracks ☒ **Mortar** ☐ Roots ☐ Wall

Infiltration: ☐ None ☐ Joint ☐ Cracks ☐ Mortar ☐ Roots ☒ **Wall**

chimney& corbel infiltration

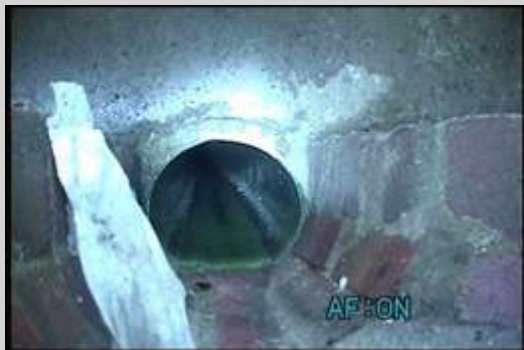
12 O'Clock Outflow

Pipe Height: **8.4** (in.) Rod and Bar (Angled)
Pipe Material: **PVC** ☐ Pipe Lined
Invert Depth: **7.84** (ft.) Flow Characteristics: **None**
Deposits: ☒ None ☐ Mud ☐ Sludge ☐ Debris ☐ Grease
Silt Depth: **0** (in.) Deposits Extent:
Infiltration: **None** Pipe Seal Cond: **Sound**

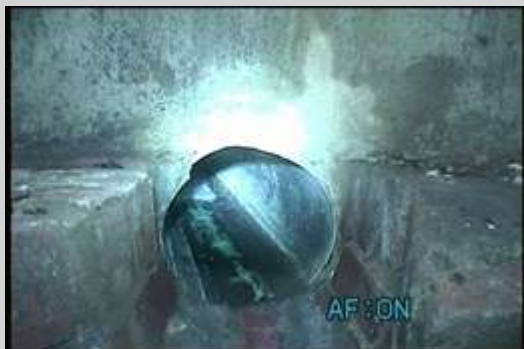
3 O'Clock Inflow

Pipe Height: **8.4** (in.) Rod and Bar (Angled)
Pipe Material: **PVC** ☐ Pipe Lined
Invert Depth: **7.72** (ft.) Flow Characteristics: **None**
Deposits: ☒ None ☐ Mud ☐ Sludge ☐ Debris ☐ Grease
Silt Depth: **0** (in.) Deposits Extent:
Infiltration: **None** Pipe Seal Cond: **Sound**

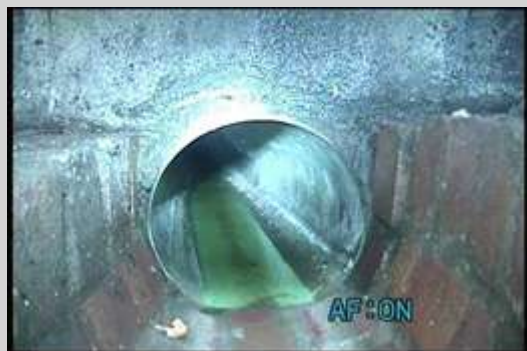
6 O'Clock Inflow

Infiltration: **None** Pipe Seal Cond: **Sound**
